Case Title	Two 50DF Voyage Overhauls and leaking Cyl. Liners
Machinery Type	Wartsila 2 (x) W12V50DF
Achievement Date	March 2021

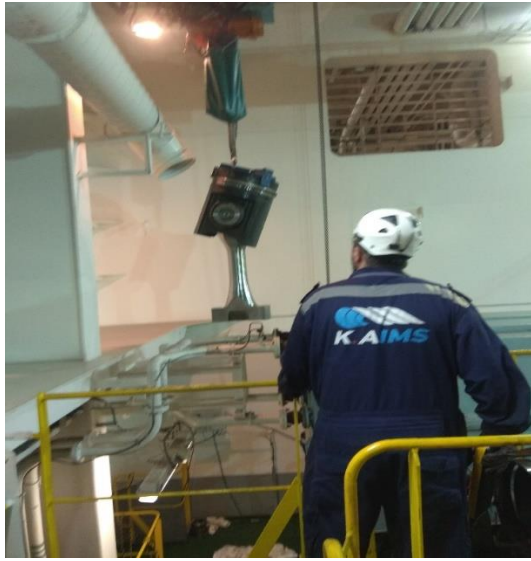
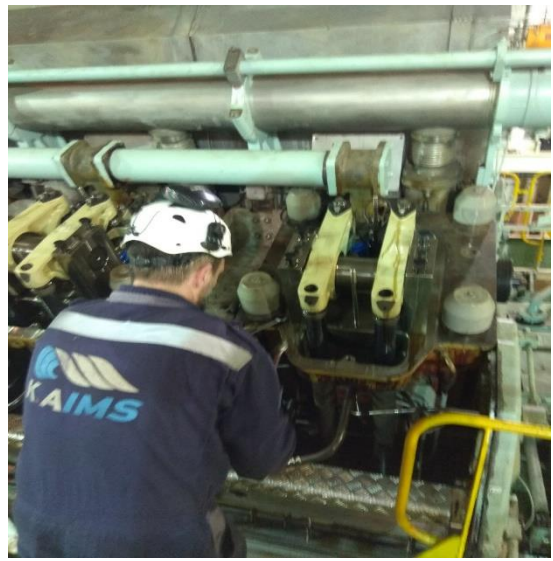
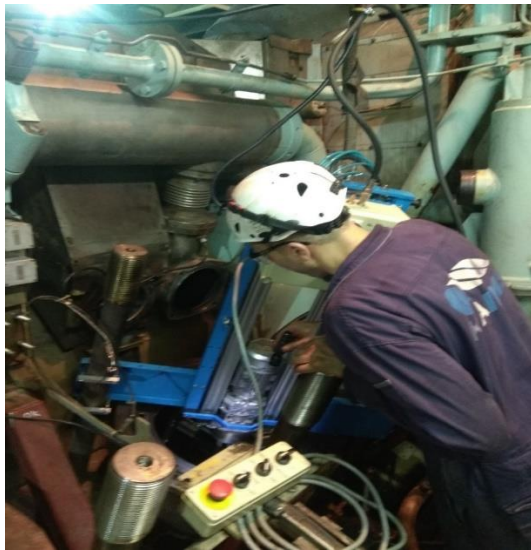
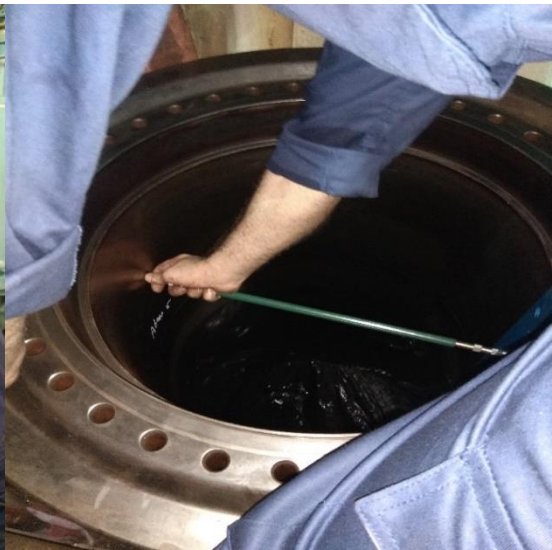
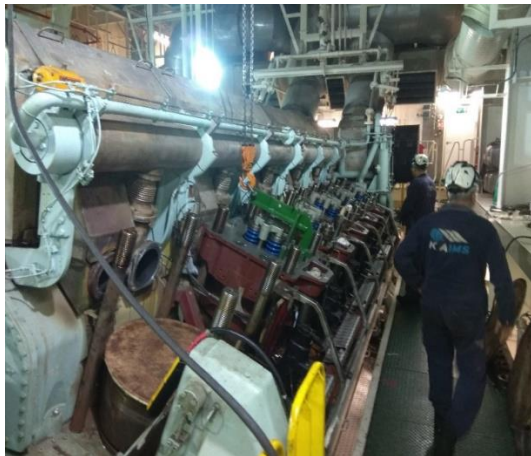
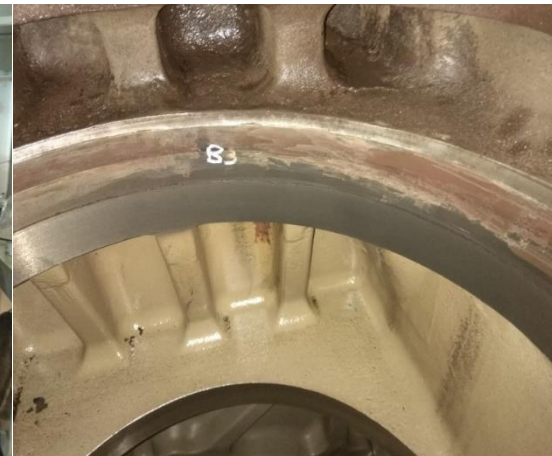
One of our client's was facing a Cylinder Liner leakage on his Wartsila W12V50DF MGE, he was technically advised to install workshop manufactured sleeves on the cylinder liners. This would majorly increase the associated costs and of course affect the timeframe of completion of the overhaul.

Regarding the leaking cylinder liners, using Belzona 1111 and a three-step application process, we were able to retrofit the leaking Cylinder Liners within a period of 48 hours.
