Case Title	Two 50DF Voyage Overhauls and leaking Cyl. Liners
Machinery Type	Wartsila 2 (x) W12V50DF
Achievement Date	March 2021

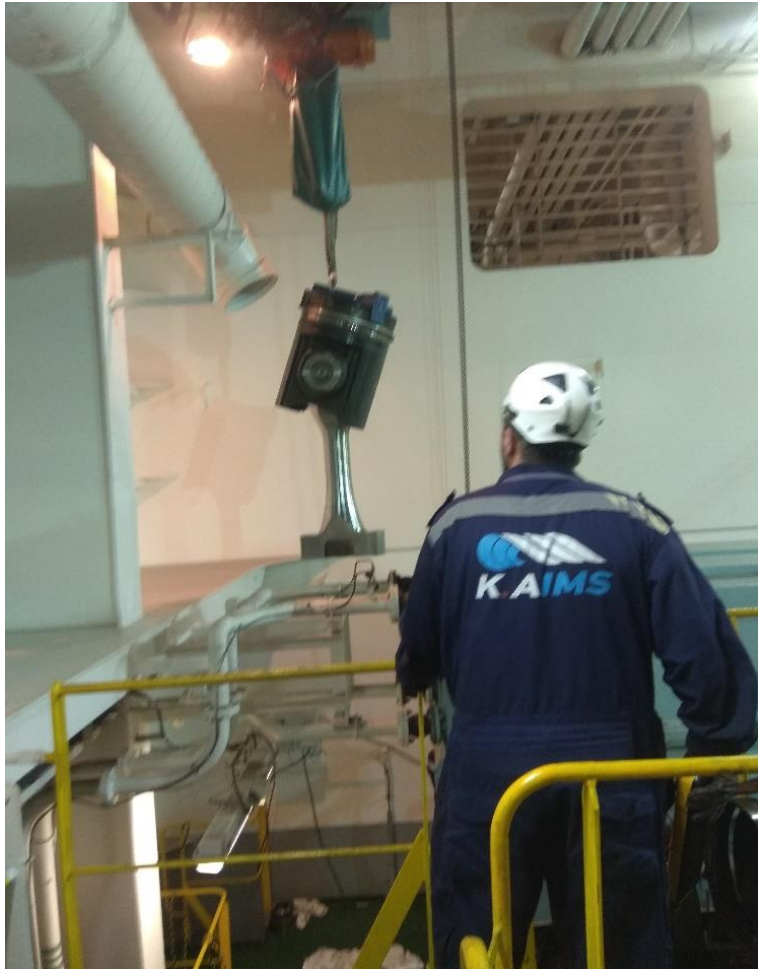
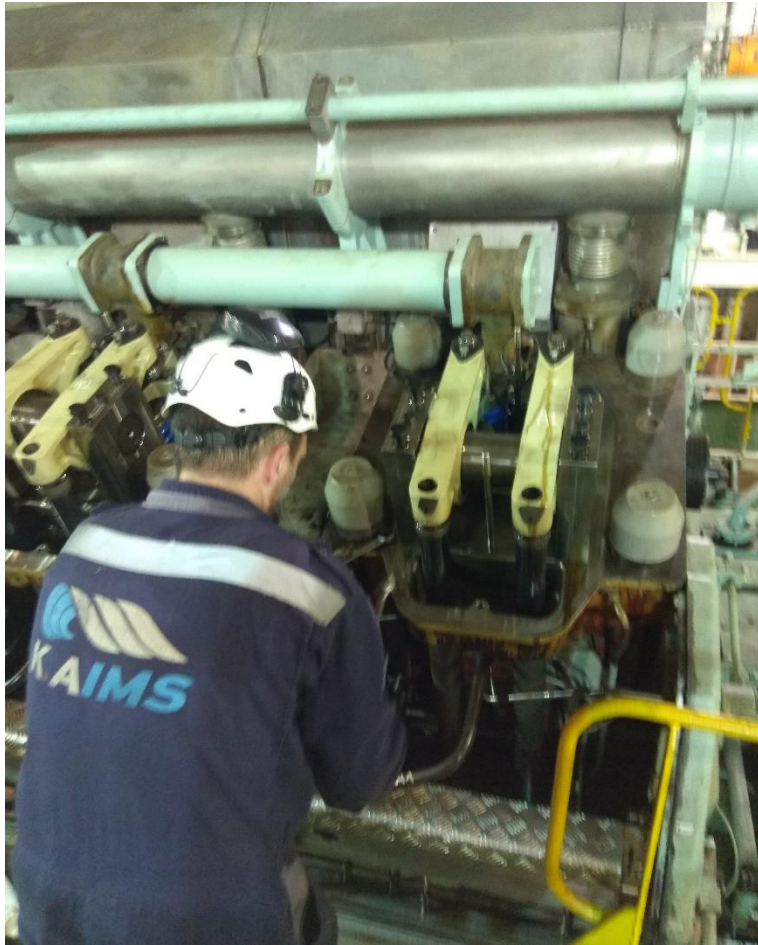
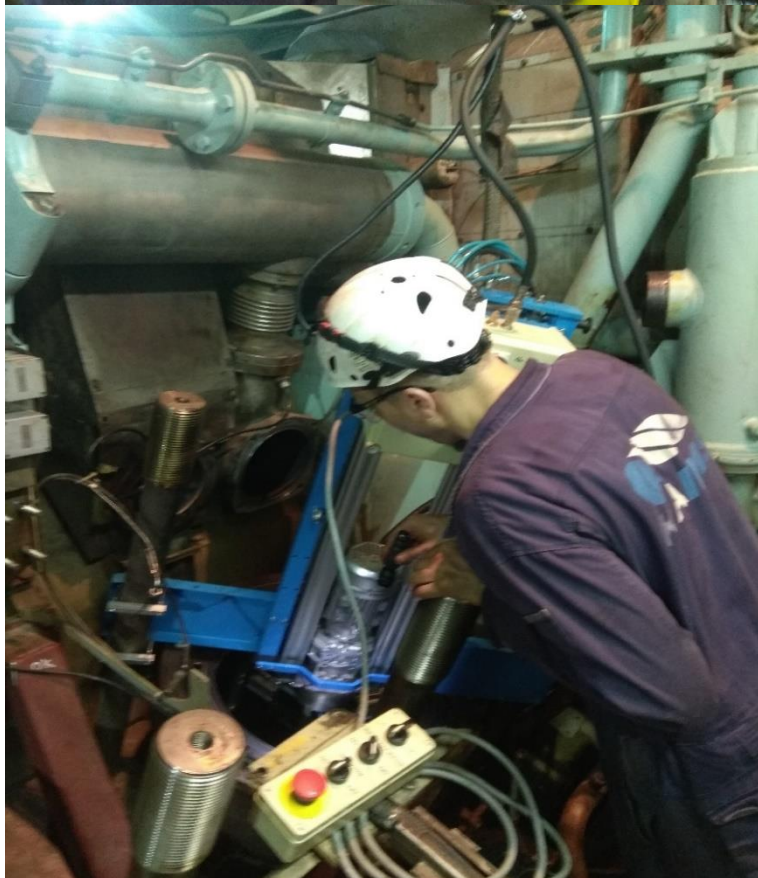
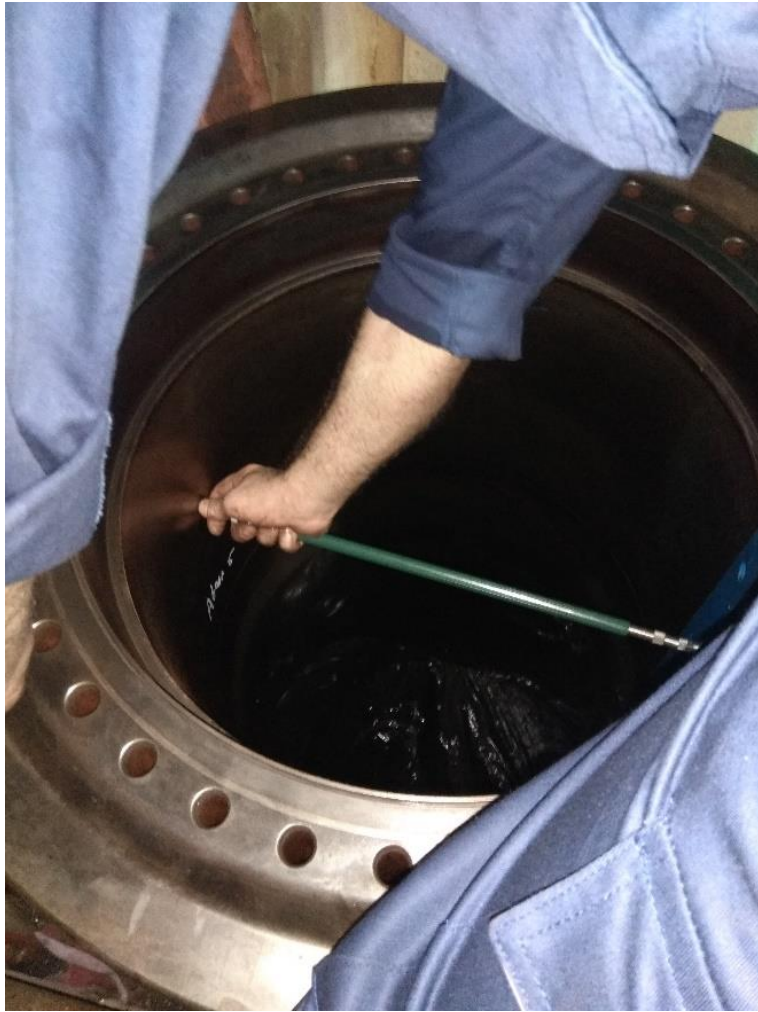
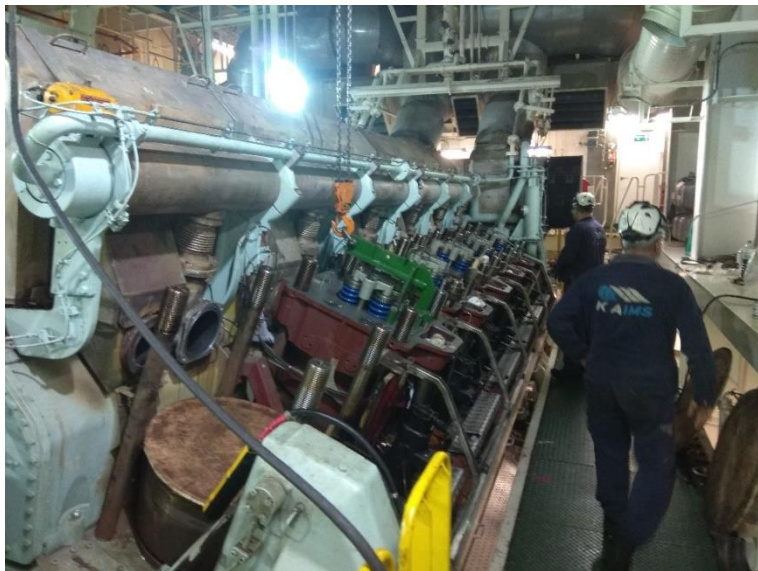
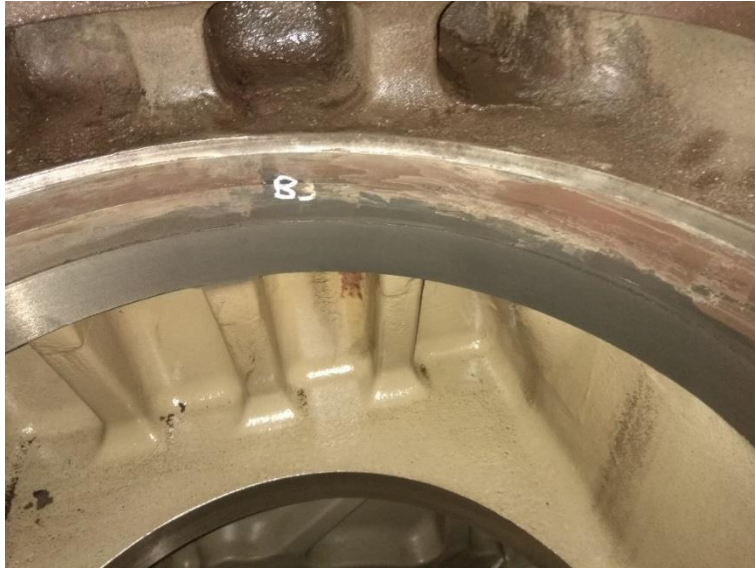
Regarding the leaking cylinder liners, using Belzona 1111 and a three-step application process, we were able to retrofit the leaking Cylinder Liners within a period of 48 hours.
